MINUTES OF JULY 10, 2018 SPECIAL PROJECTS AND FACILITIES COMMITTEE
MEETING
GLENCOE PARK DISTRICT
999 GREEN BAY ROAD, GLENCOE, ILLINOIS 60022

Glencoe Bluff and Beach Stabilization

Glencoe Beach and Bluff Restoration

Condition Assessment and Recommendations Summary

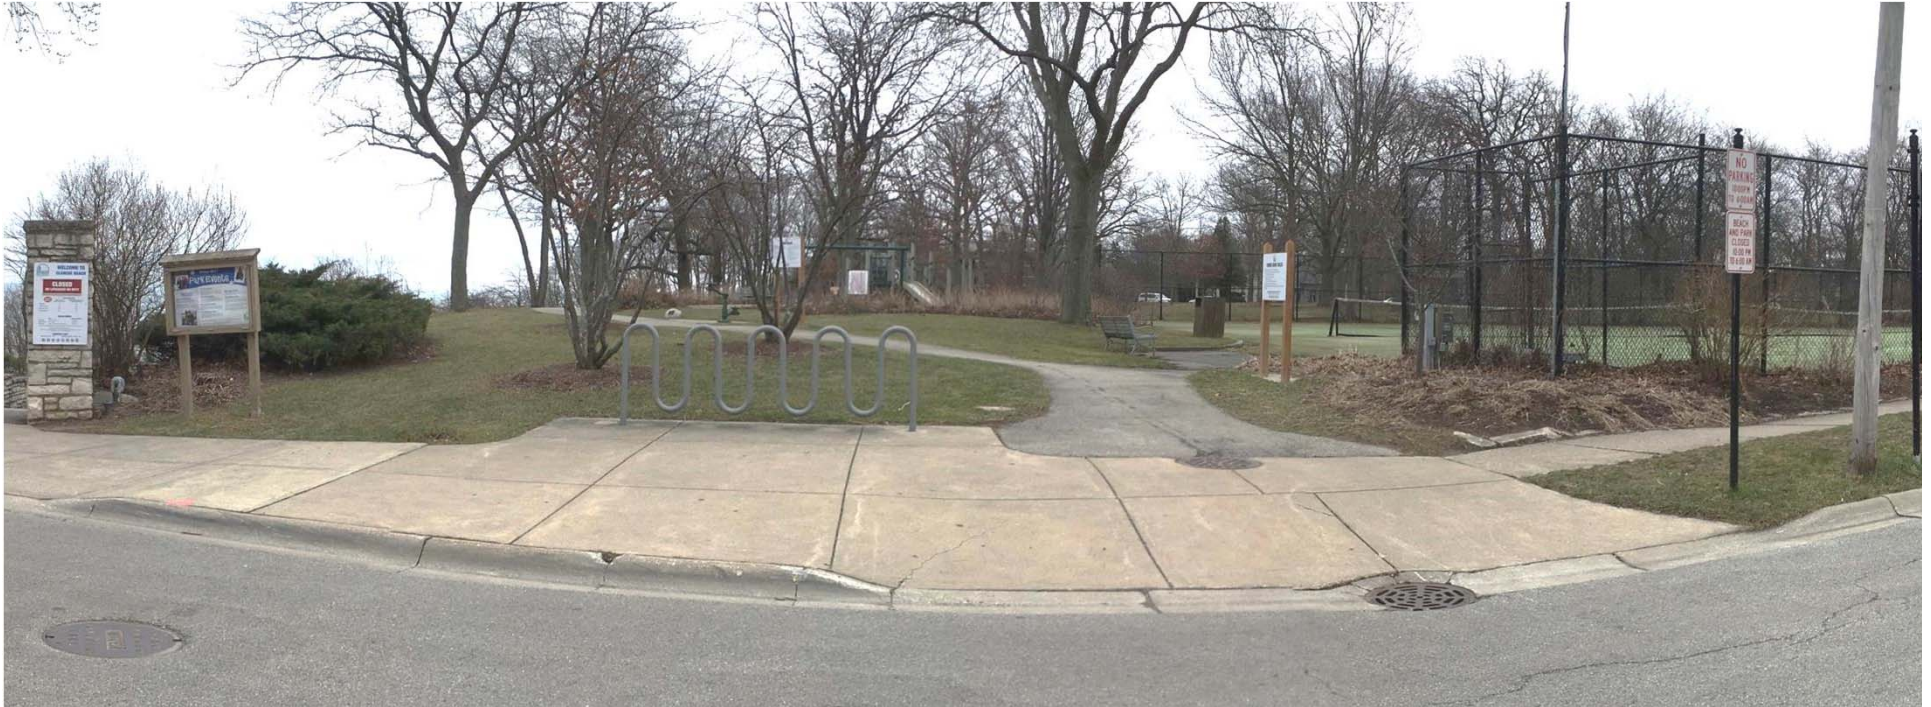
Lakefront Park Master Plan: Barriers in the Park

“Uninviting entryways”

“forced to navigate an obstacle course just to get through”

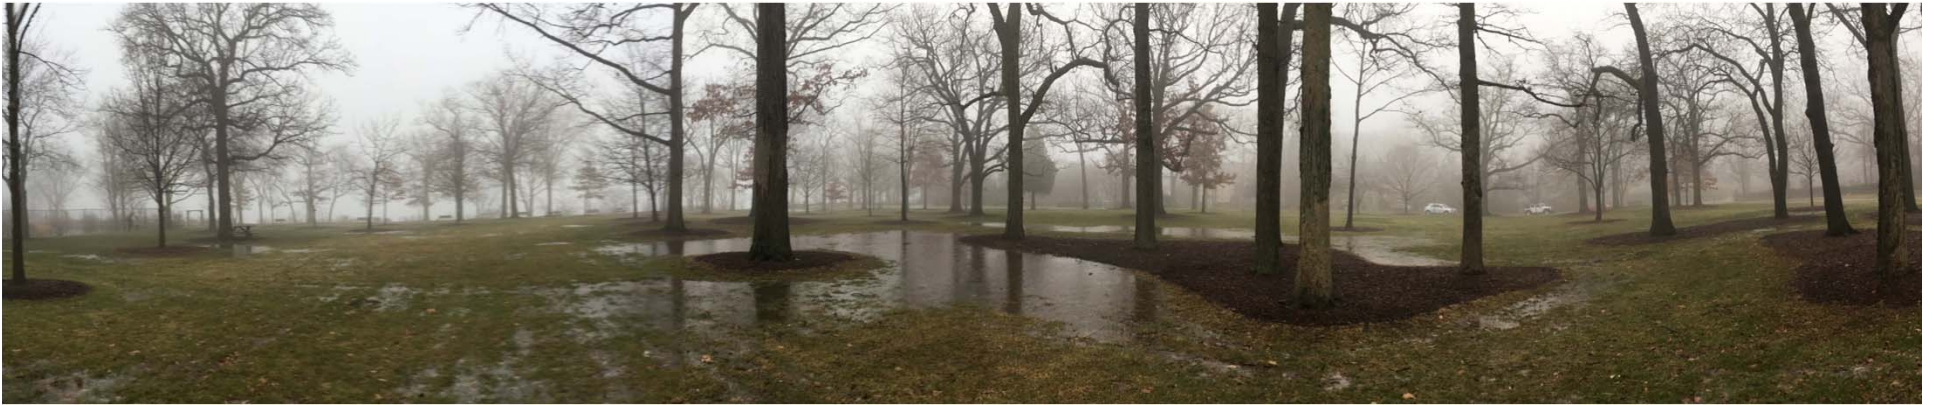
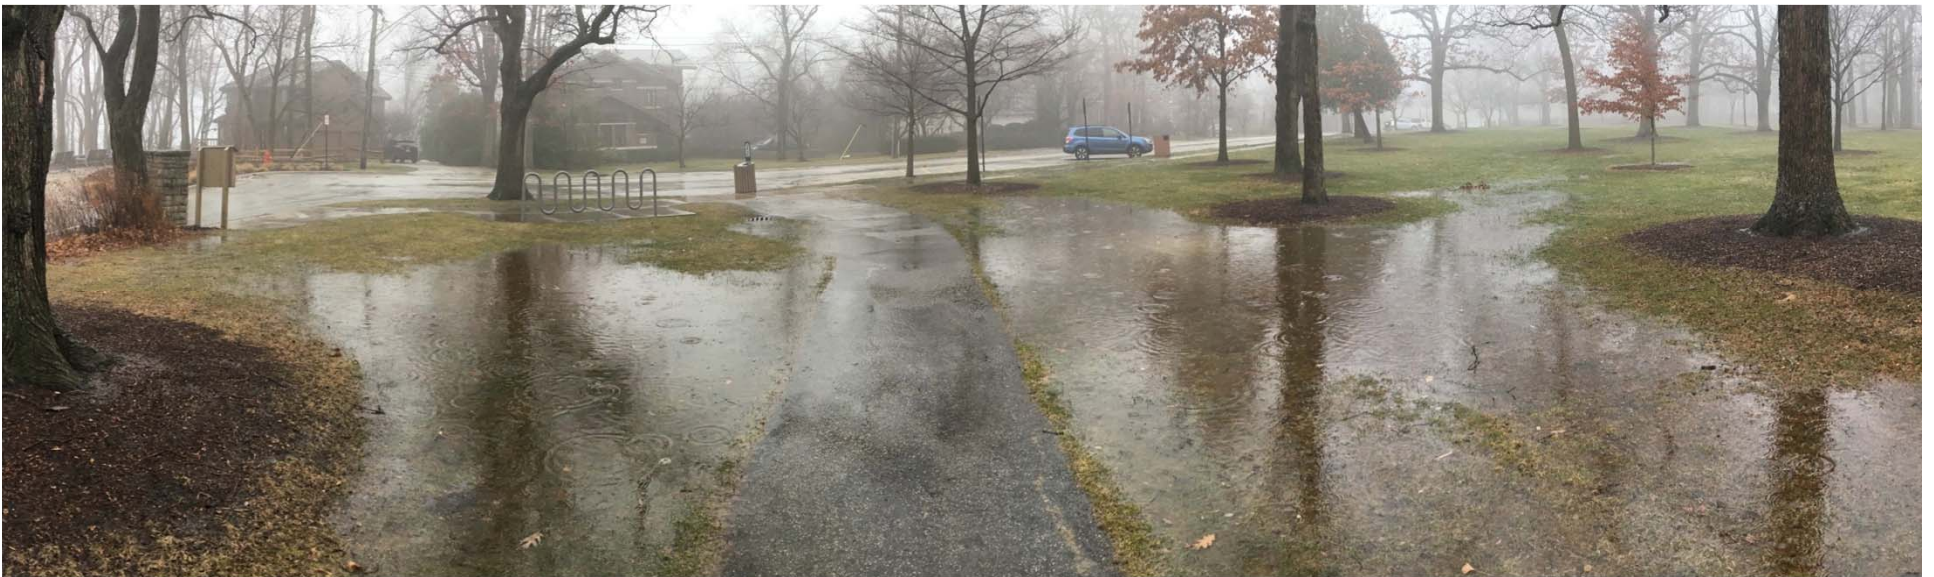
But How to Deal with Storm Water January 2017

Water Flows Across Paths in Park and Along Hazel Ave

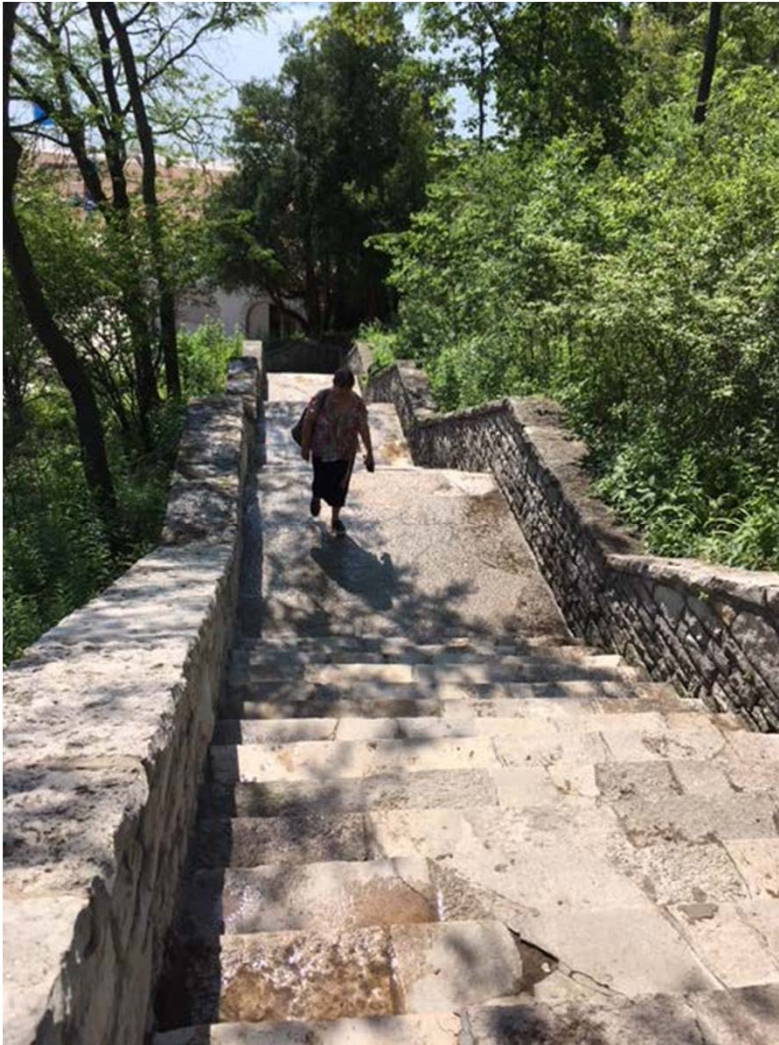
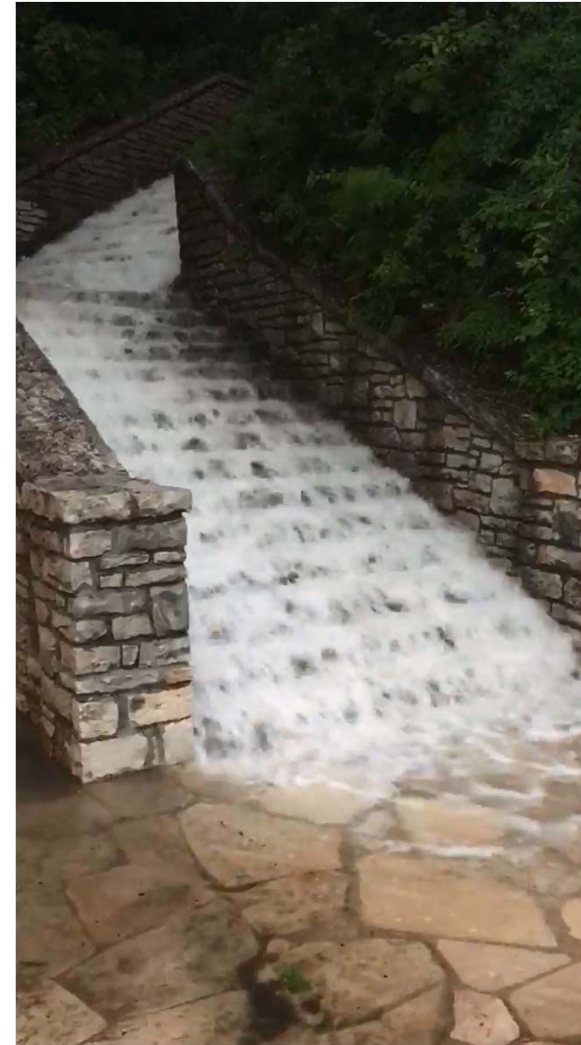
Lakefront Park: Storm Water & Drainage

Stairs and Half Way House Inundated after rainfall

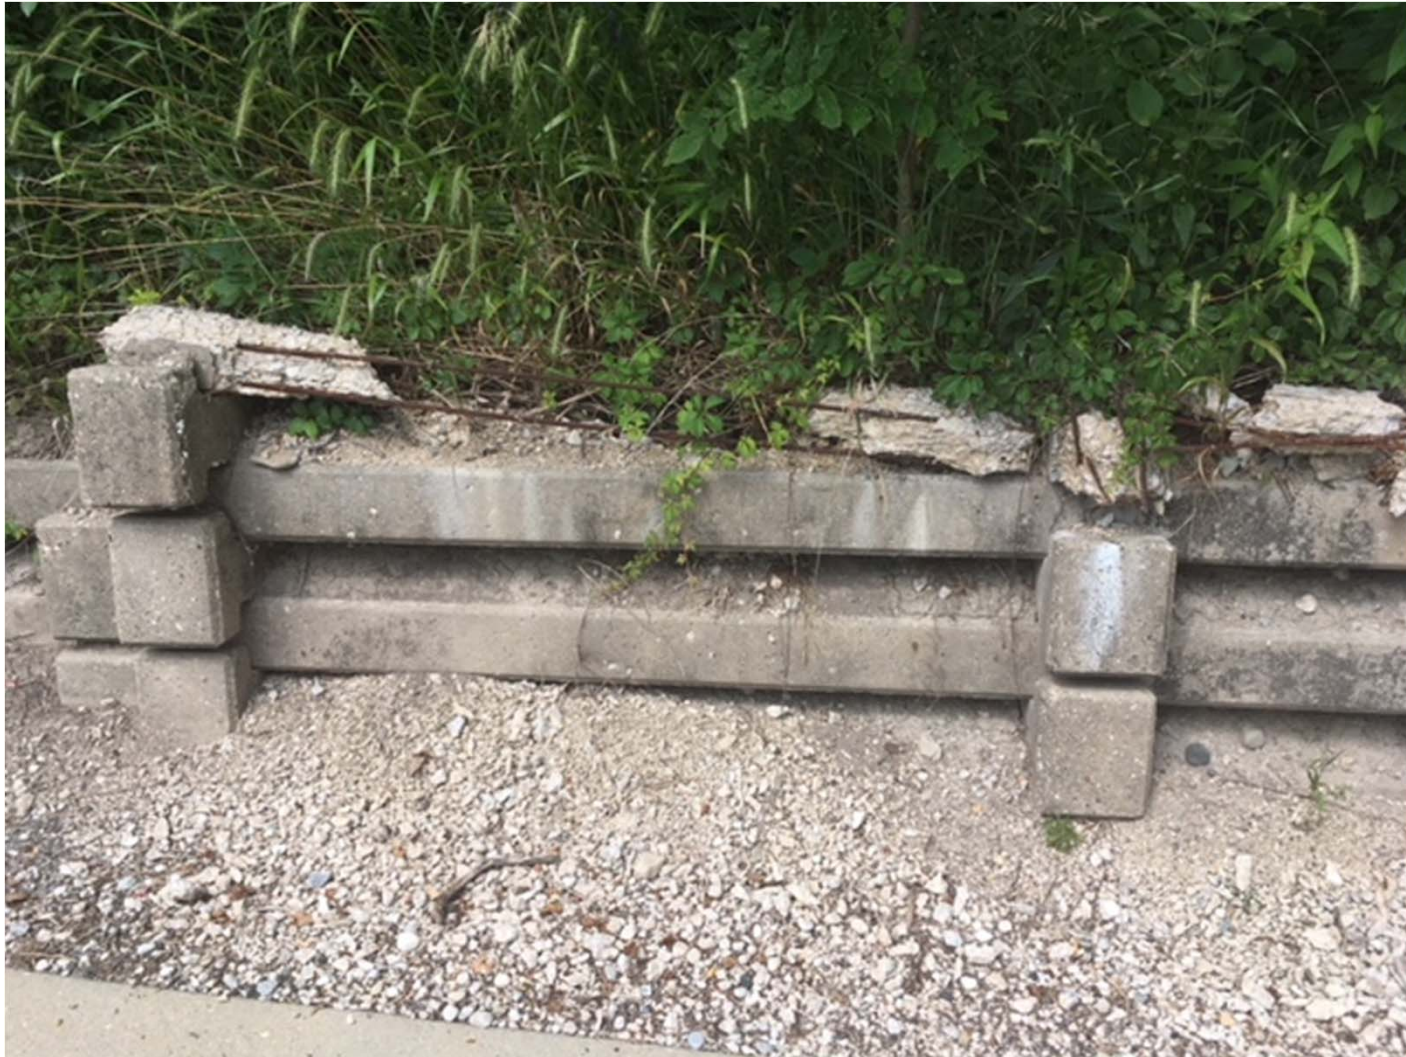
Structural Failure July 7th 2017

Cribbing Failure – Bluff is pressing down on Beach House

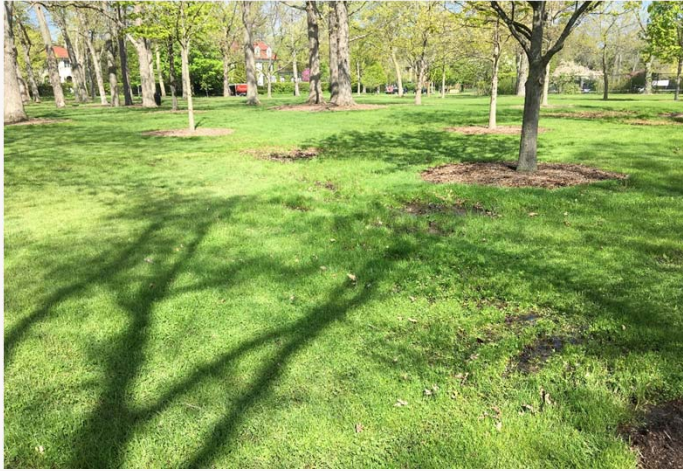
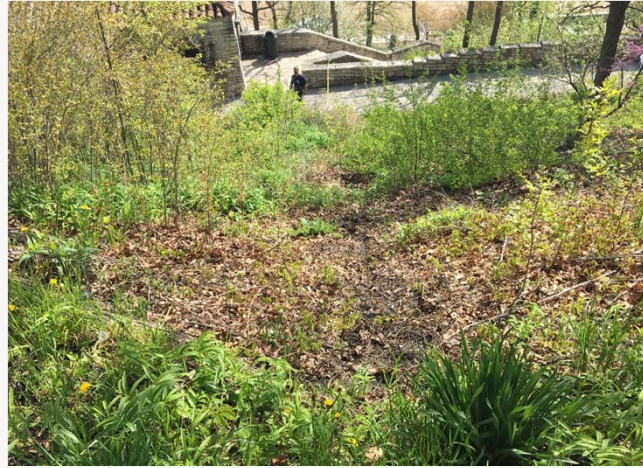
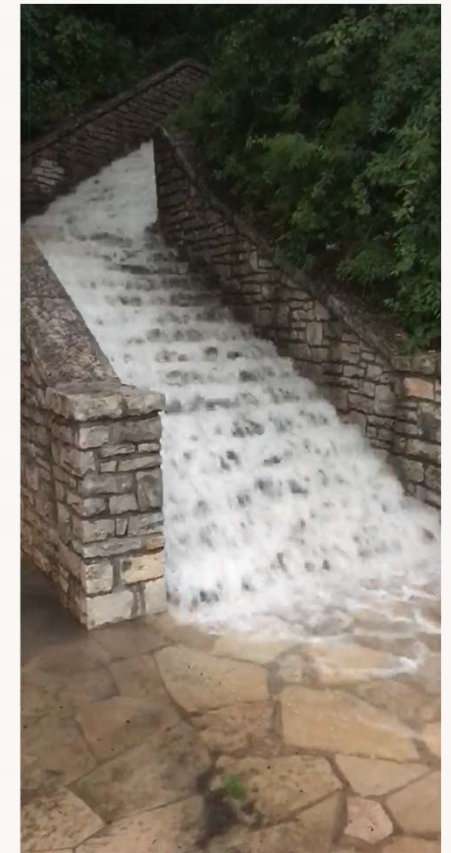
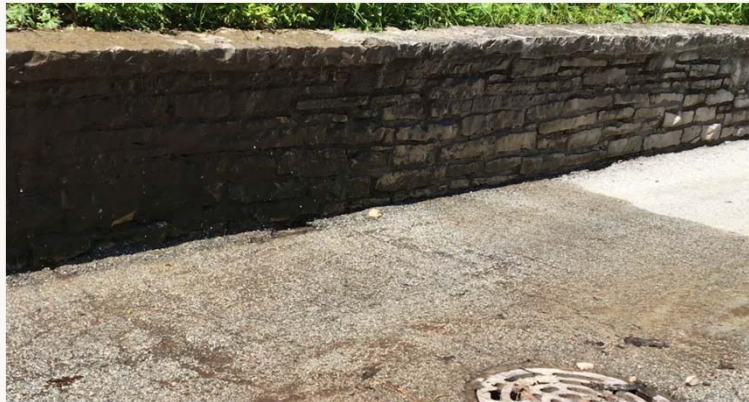
Surface-water Management – Lakefront Park / South Bluff

- Lakefront Park/South Bluff
 - Capacity of outfalls appears adequate.
 - Grading/routing/collection needs improvements to limit erosion.
- Center Bluff
 - Surface-water collected in armored ravine.
 - Capacity of outfall is adequate.
 - Recommend modifying gate/fence to limit erosion.

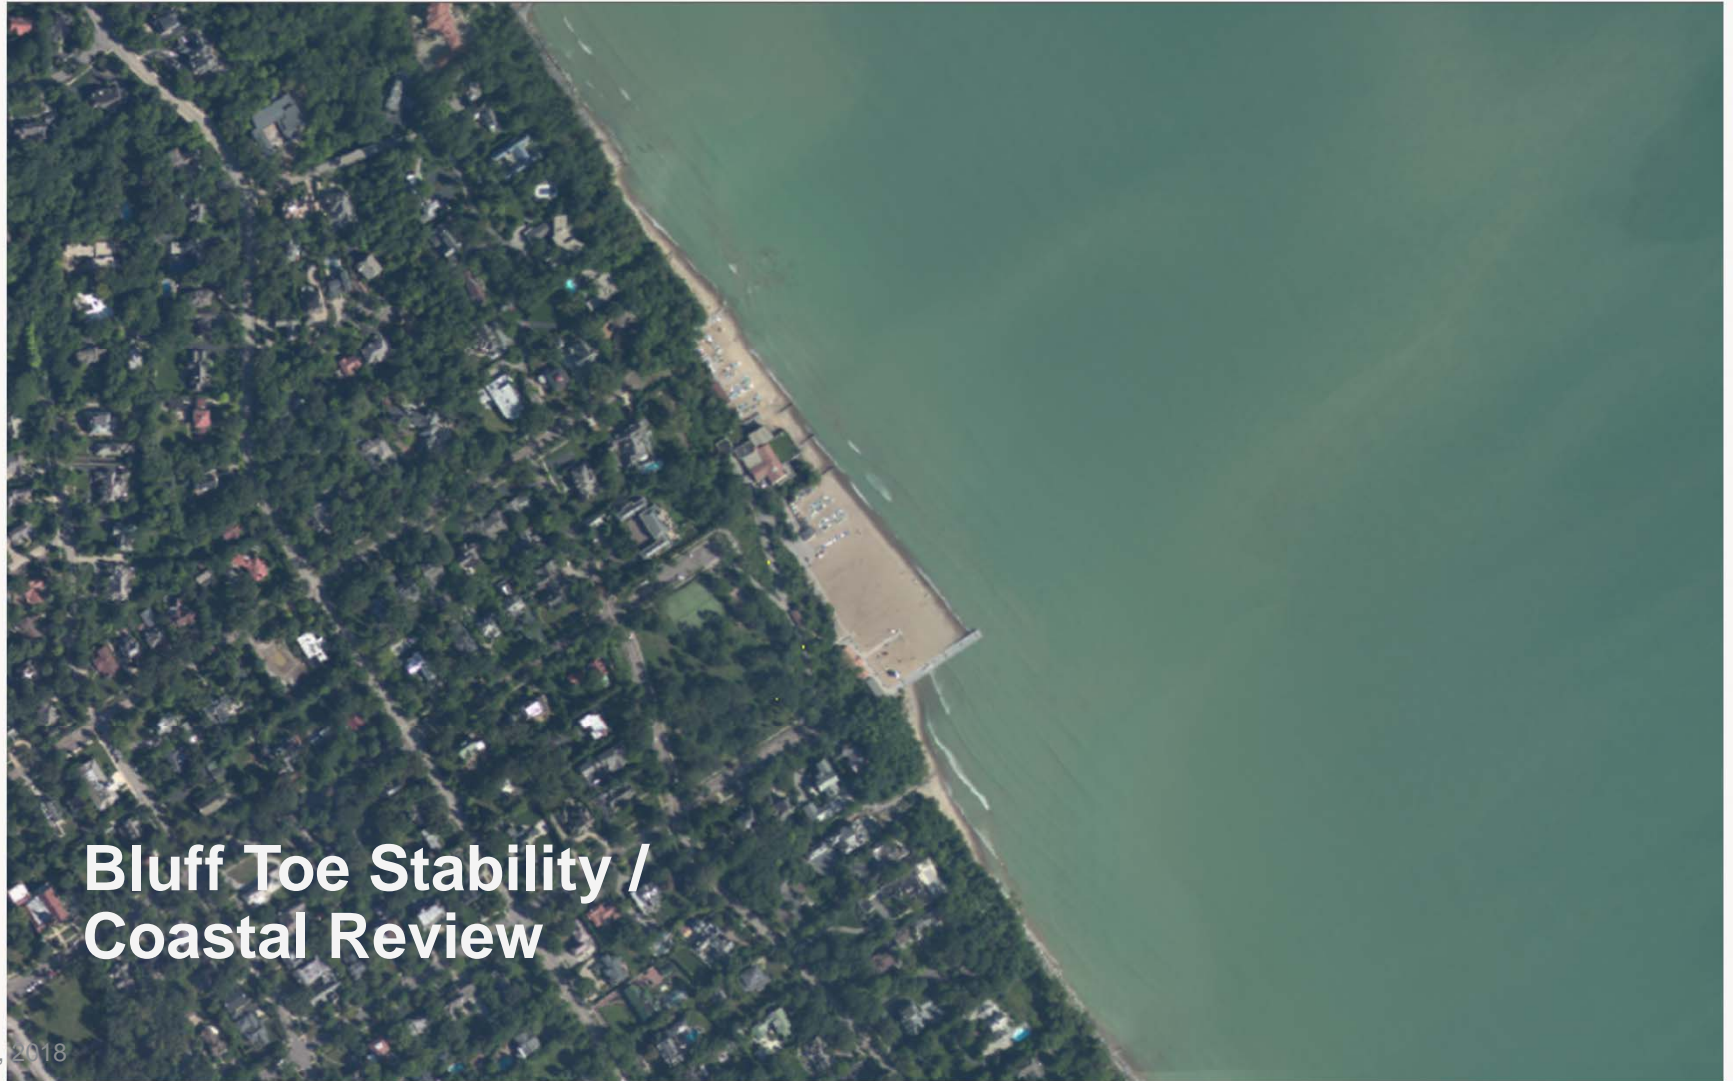
Bluff Toe Stability / Coastal Review

- Responds to natural variations in lake levels, wave action, and sediment supply/transport.
- Will continue to require beach nourishment – requirements minimized if coastal structures are added.
- Outfall design causes additional erosion.

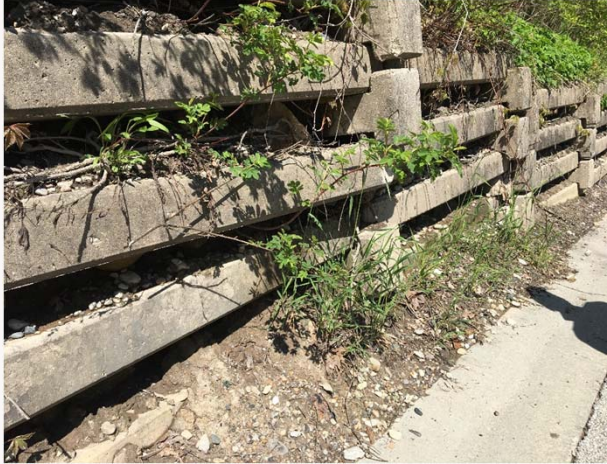
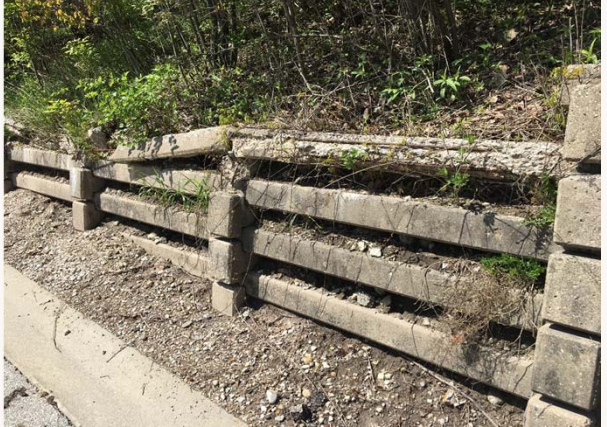
Historical Photo – 1998-99

- South Bluff & Center Bluff – factor of safety acceptable
- North Bluff & southern limits of South Bluff – factor of safety marginal
- Local stability issues likely associated with creep and surface-water drainage issues.
- Surficial creep visually observed – slow gradual process
- Southern section of South Bluff has lowest factor of safety.

Priority Level	Recommendations
High Priority	<ol style="list-style-type: none">1. Restore North Overlook2. Surface-water Management Modifications3. Replace Crib Wall
Medium Priority	<ol style="list-style-type: none">1. Restore/Replace Lower North Roadway STW and curb2. Restore Upper North Roadway STW3. Fill "The Cave"4. Restore Halfway House
Low Priority	<ol style="list-style-type: none">1. North Beach Outfall Modifications / Add Coastal Structures?2. Restore South Overlook3. Improve Beach House Drainage
